HOUBATONIC RIVER BASIN  
NORFOLK, CONNECTICUT

WOOD CREEK  
DAM - CT 00486  
DIKE - CT 01707

PHASE I INSPECTION REPORT  
NATIONAL DAM INSPECTION PROGRAM

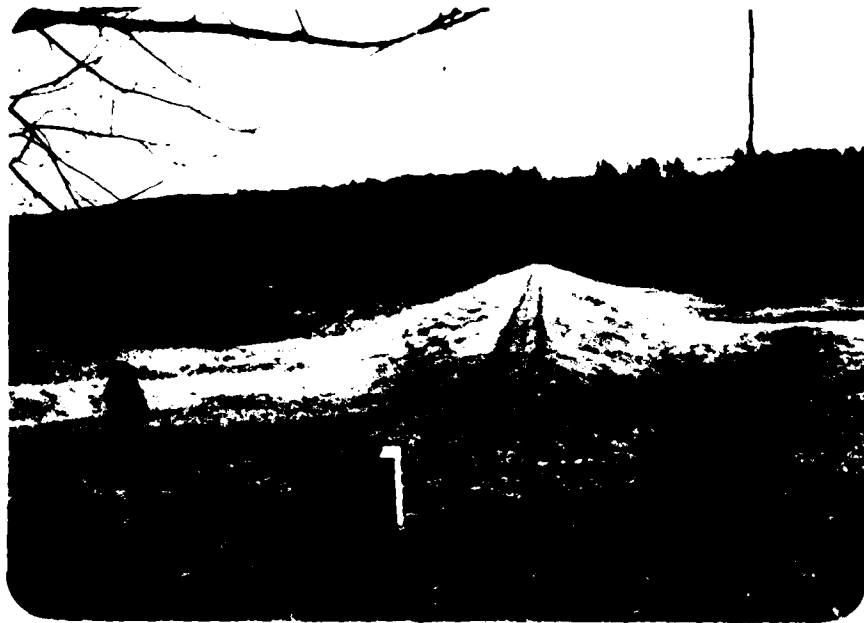
PHOTO NO. 1

DAM EMBANKMENT FROM RIGHT ABUTMENT.

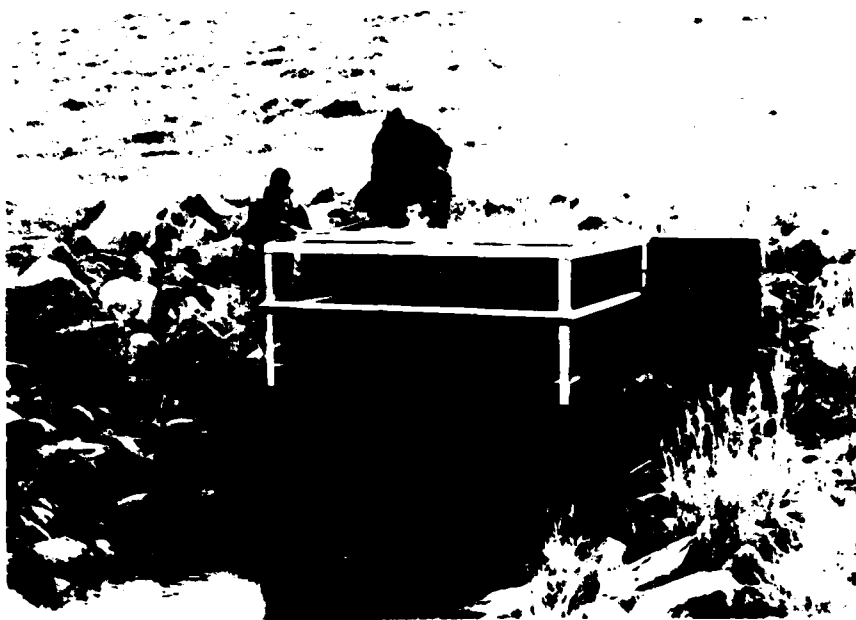
PHOTO NO. 7

DROP INLET WITH GALVANIZED STEEL TRASH RACK.

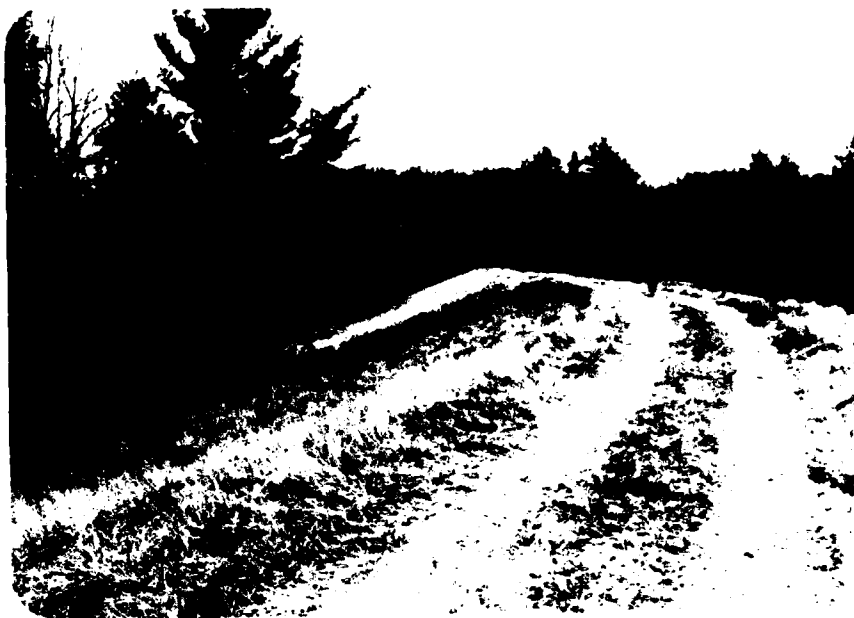
PHOTO NO. 15

DIKE LOOKING TOWARD RIGHT ABUTMENT.
